=| SAFETY FLASH 2021-01 |=

Failure of in-service saturation bailout bottle

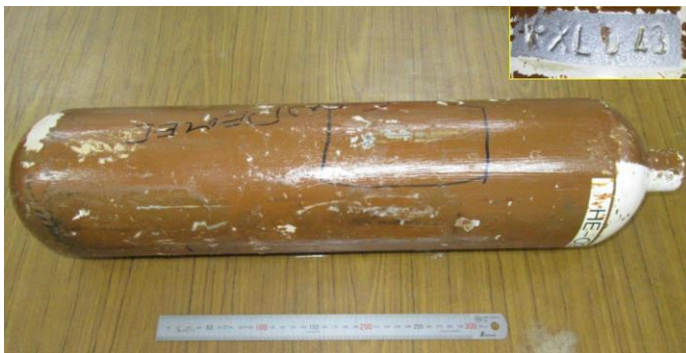
Upon recovery to deck, the bailout bottle was found to have 3 pin holes on the side wall hidden by a locking clasp. Saturation diving operations were suspended and all bailout bottles from the same manufacture of the same type were taken out of service and quarantined.

Leaking cylinder

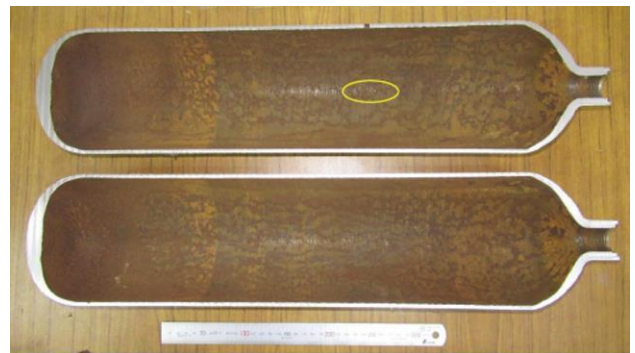
Internal surface of cylinder, showing corrosion over entire surface. Leak location circled.

- The primary factor was water/moisture on the internal surface of the cylinder, promoting corrosion. High levels of chlorides and possibly produced hydrogen may have led to the Stress Corrosion (SCC) and/or Hydrogen Stress Cracking (HSC) mechanisms;
- The root cause was suspected to be third-party testing and/or unsuitable long-term storage.

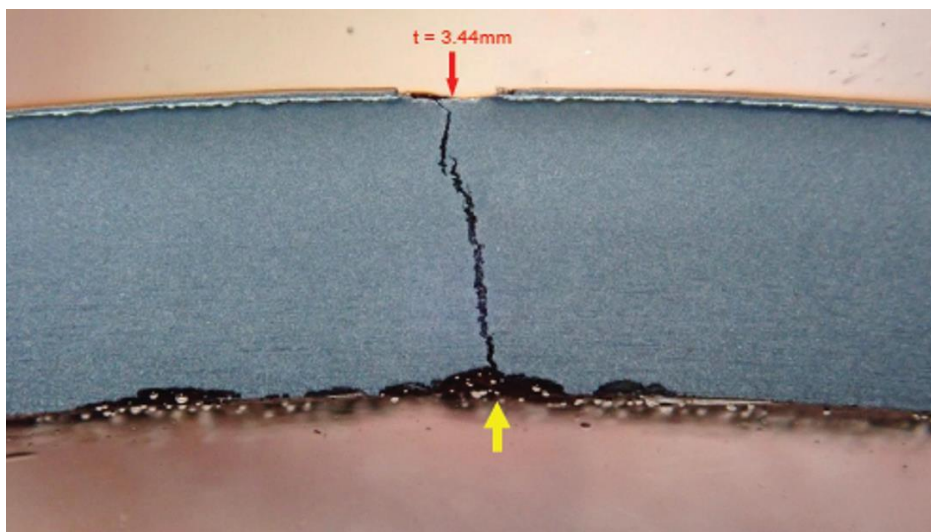
A cross-section through the cylinder wall at the leak location showing a through-thickness crack. The cylinder suffered internal corrosion at the crack location, with a measured remaining wall thickness of 3.44mm.

A through-wall defect 42mm long approx. was observed, with 3 small leak paths.

- Improvement required for technical specification for servicing, testing and inspection of bailout bottles;
- Drying procedure used by supplier deemed to be inadequate;
- Bottle receipt and storage process deemed inadequate - potentially exacerbating internal corrosion.

- Verify that third-party procedures are fit for purpose and followed;
- Improve receipt inspection and storage of bailout bottles to ensure they are dried and sealed.
