*Information sourced from IMCA Safety Flash*

## Failure of EGS valve stem on dive helmet

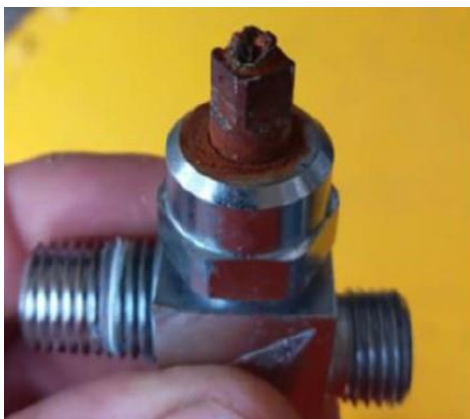
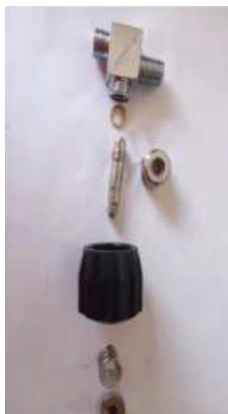
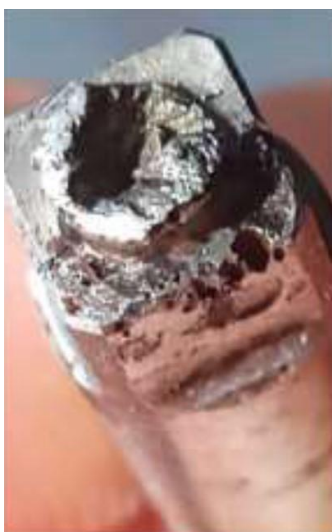
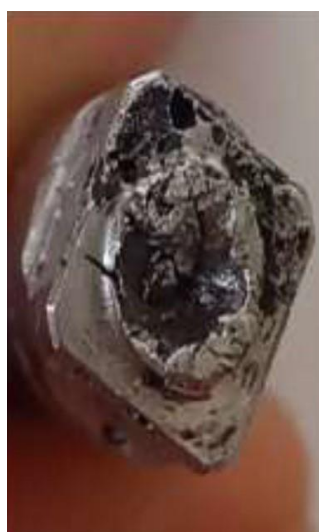
A dive technician stripped the valve and discovered the break to be located at the valve stem – where the threaded portion meets the square section. Both parts of the valve stem, adjacent to the break, were noted to be pitted and a fine hairline crack was noted. The failed component was replaced with a new spare. Following a gas leak and function test, the dive helmet was placed back into service. The failed component was sent ashore for further investigation.

The member arranged an independent laboratory review of the material to try and identify the root cause. The finalised laboratory report indicated that failure occurred as a result of pitting and stress corrosion cracking under the action of the chlorides present in salt water.

- Following its investigation our member took the following actions:
  - The company preventative maintenance system (PMS) was modified to require NDE dye penetrant testing of EGS valve stems for all base and field diving helmets at a minimum of 12 monthly intervals.
  - Internal instructions were issued stating that if the post-dive, inspection, or maintenance routines recommended by the manufacturer highlighted any concerns, the relevant valve stem(s) should undergo immediate NDE dye penetrant testing. If any anomalies are then detected, the component should be discarded and replaced.

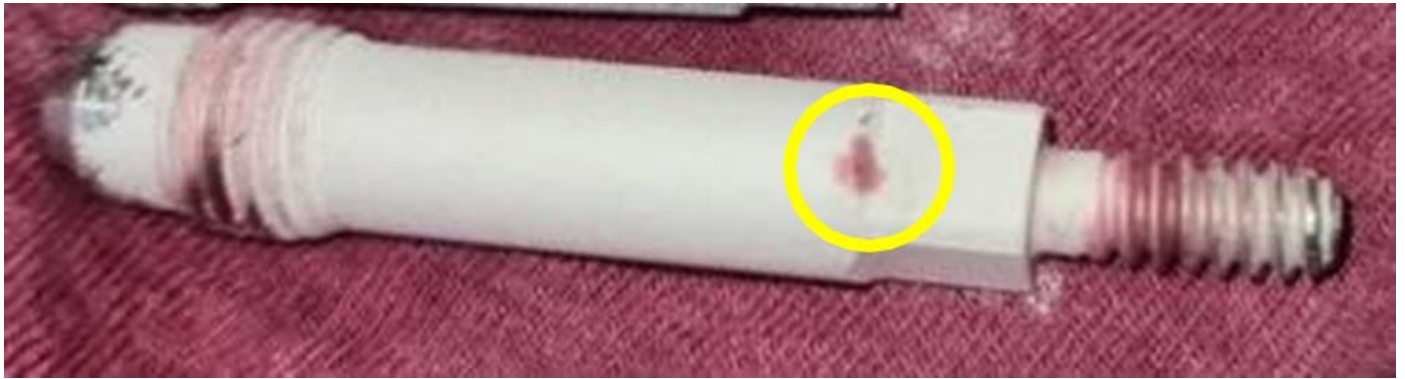
Since these measures were put in place our member has identified three additional valve stems with stress-like indications in the material. Note the pin hole in this example that our member detected in a rental asset:
