## MSF: Air cylinder failure in lifeboat

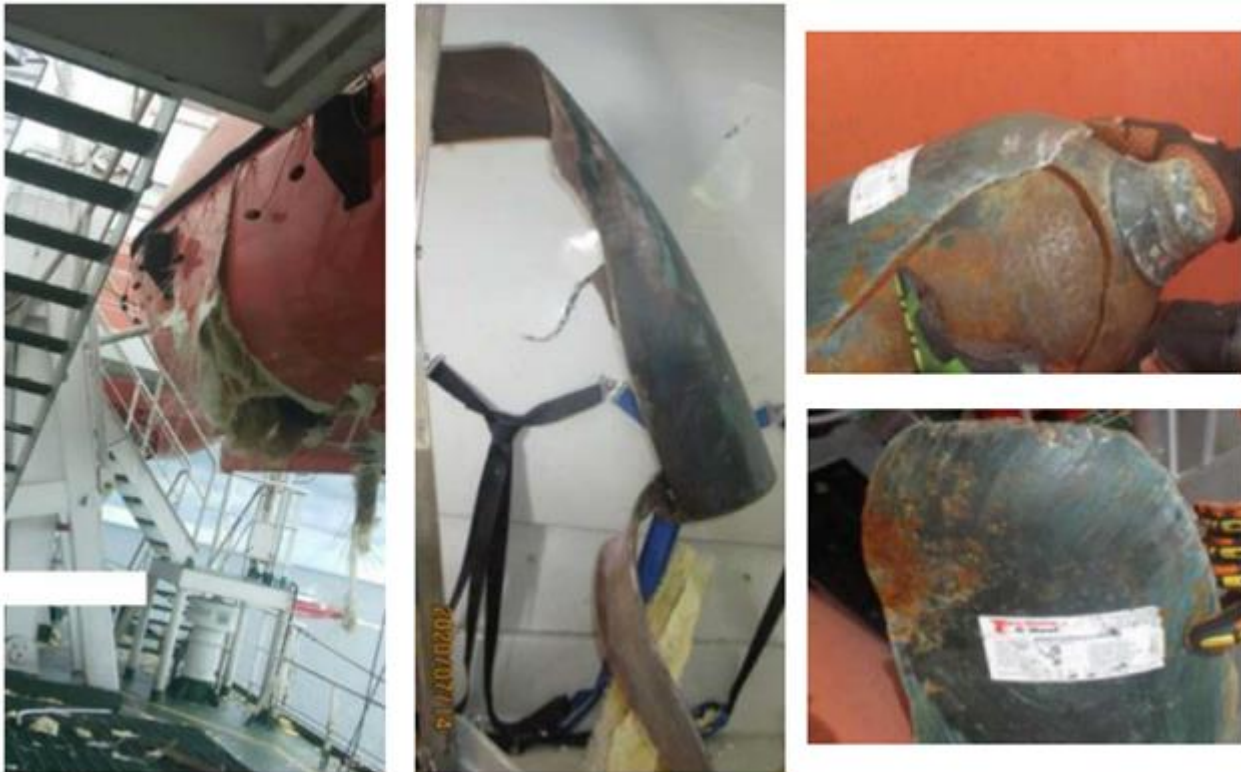
There was a structural failure of an air cylinder fitted in a lifeboat. It occurred without warning. No work had or was being conducted on or around the air cylinder. Three crew members working nearby were injured by the blast debris.

Two preliminary suspected causes of the cylinder failure have been identified:

- Galvanic corrosion between the cylinder material and the metal support frame leading to a weakness in the cylinder wall;
- Cylinders submerged in bilge water for extended period leading to wall corrosion which could have then affected the integrity.

The MSF's correspondent recommends that such cylinders are:

- Inspected annually for corrosion or wall damage by service providers;
- Hydrostatic [pressure] tested at a required interval of five years.
