Information sourced from IMCA Safety Flash

Failure of first stage regulator low pressure (LP) blanking cap

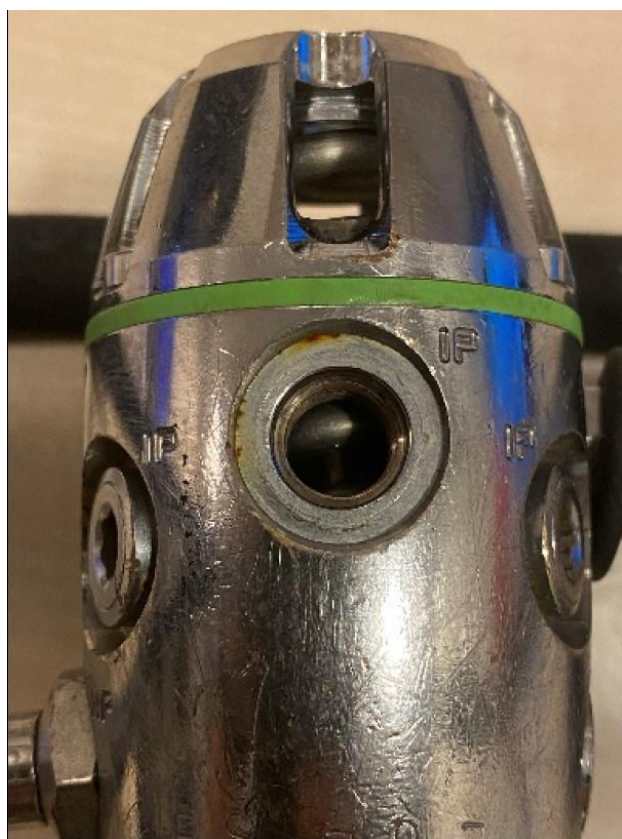
During a dive, a leak was noted coming from the first stage of diver #2's regulator on the bail out bottle. Further inspection identified that the low-pressure port blanking cap was found to have failed. The dive was terminated, the divers recovered safely, and the regulator was removed from service.

Regulator with 1st stage with low pressure port identified

- Immediate actions:
 - Manufacturers recommendations
 - O-rings to be replaced at each service or every two years
 - Confirm torque settings of 2N to be applied to all blanking caps
 - Diving Contractors actions
 - Replace all blanking caps and O-rings on existing in-service 1st stage regulators;
 - Update work orders to confirm torque settings of 2N to be applied to all blanking caps;
- Further actions:
 - Release as IMCA safety flash;
 - Identify and assess condition of all 1st stage regulators that have been in service in excess of 10 years for possible replacement.

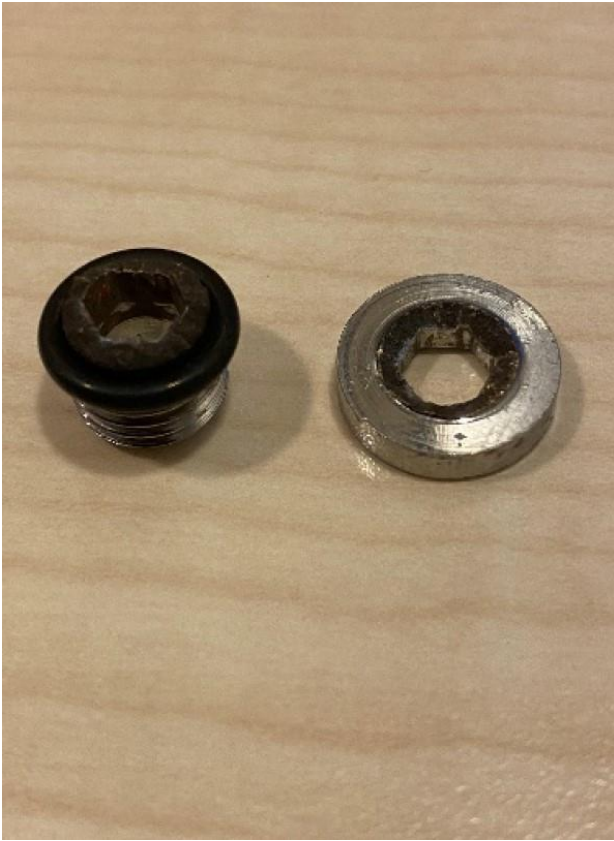
The regulator manufacturer was contacted regarding the shelf life of the blanking screws and recommended O-ring replacements.

The two pieces of the failed blanking plug
