*Information sourced from IMCA Safety Flash*

## Failure of COBRA contents pressure gauge

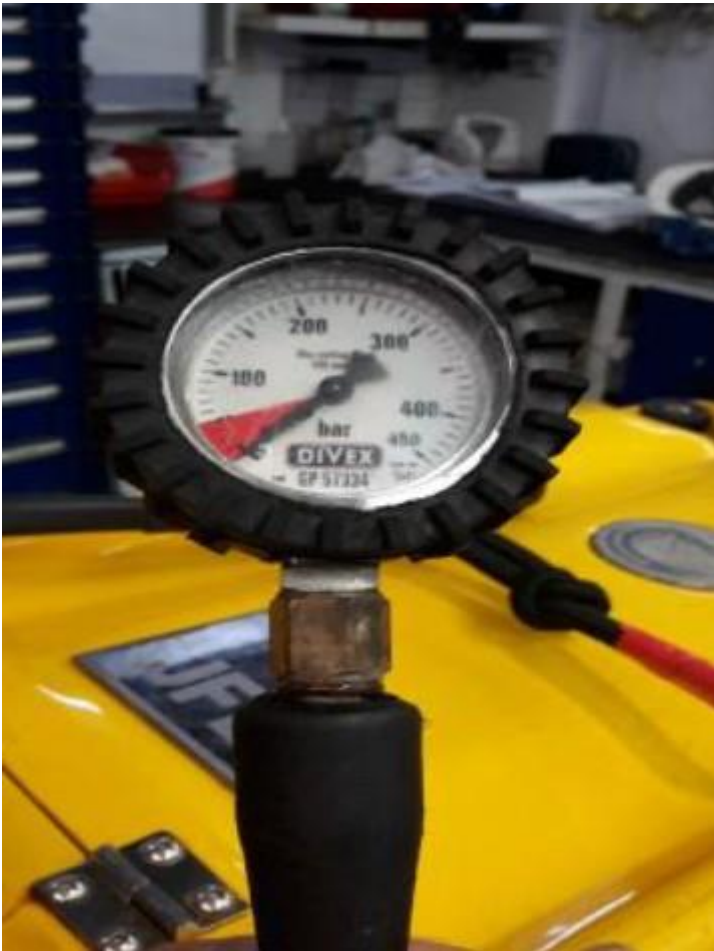
Whilst at the COBRA charging station in the bell hangar during project mobilisation, a diver was venting a COBRA unit, prior to charging. The diver opened the valve slowly, and when the gauge reached 100 bar a 'popping' sound was heard and the gauge fell to the floor. The diver immediately closed the valve and reported to the Dive tech Supervisor.

Area where gauge failed

- Immediate Cause – failure of thread
- Underlying Cause – impact load placed on thread connection during use
  - Dive technical examination by subject matter experts concluded that the thread failed due to dynamic damage, likely caused by being bumped, knocked or stood on during use.

- All COBRA and bail out gauges inspected and replaced as necessary;
- Planned Maintenance System updated to include monthly inspection of contents gauge, inclusive of gauge being removed from the HP hose to check integrity of fittings;
- Third-party inspection of failed gauge;
- Improved traceability through all contents gauges being serialized units.
