Information sourced from IMCA Safety Flash

Bailout manifold failure

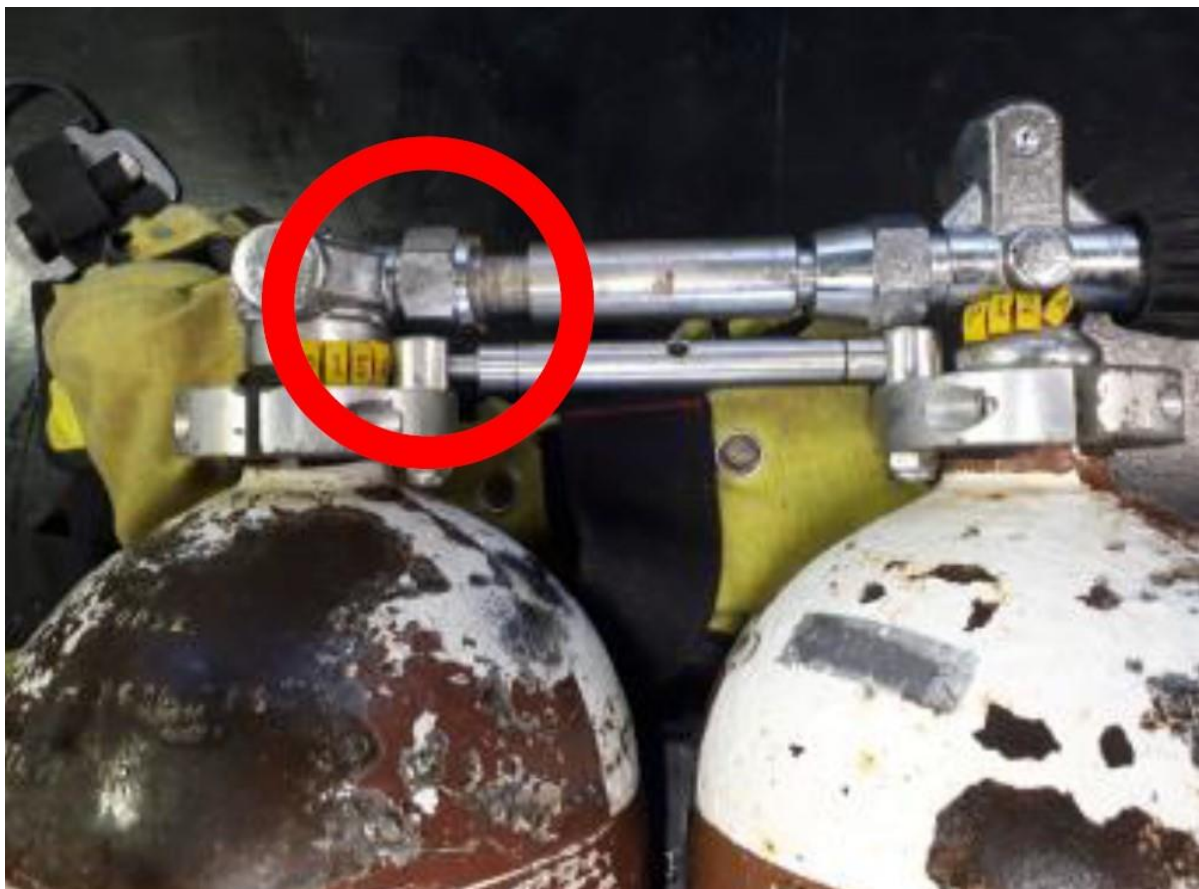
A little over an hour after the bell checks, the dive supervisor heard a sudden rush of gas over the comms. A check of the bell internal camera showed visible misting (as from a gas leak). Initial investigation lead to the discovery of four pieces of a failed nut from the bailout manifold assembly.

Bailout manifold assembly example showing location of failed nut

- Replaced these particular bailout manifold assemblies with a more robust version currently in use elsewhere in the fleet;
- Ensure familiarity with planned maintenance tasks relating to bailout alignment, integrity and boots;
- Circulate to industry: the forensic analysis report indicates the nuts used are manufactured from copper alloy CW614N which is susceptible to stress corrosion cracking and dezincification. It is known that these are widely used on manifold assemblies in the industry.

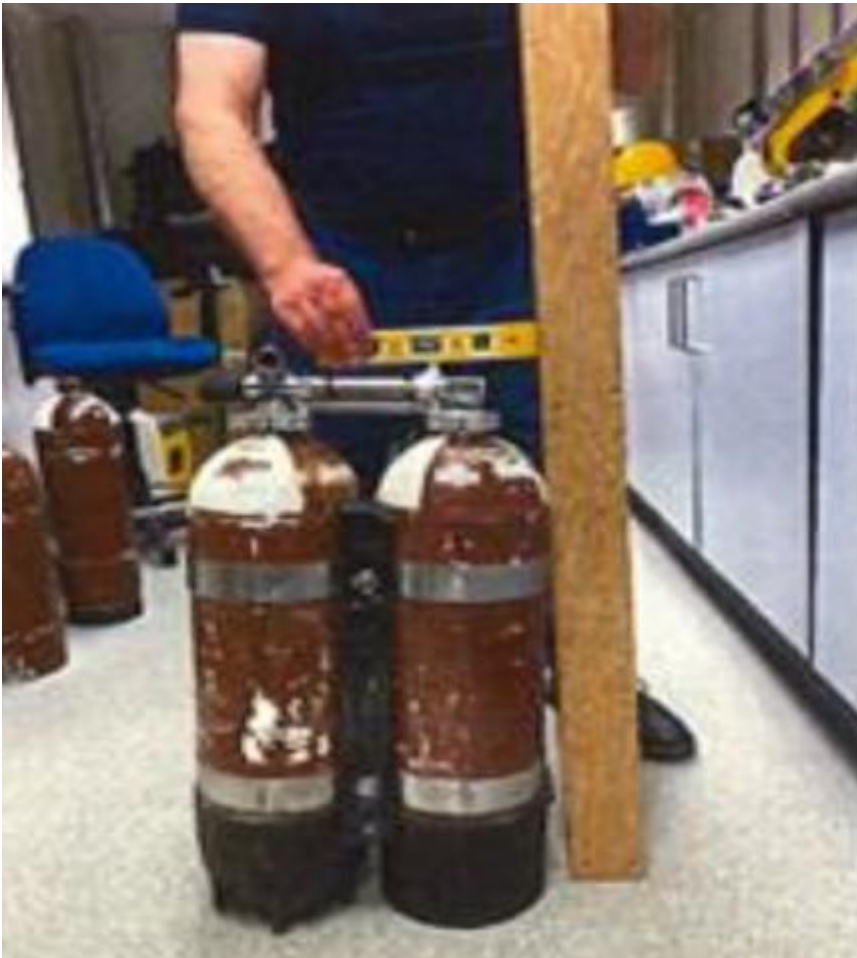
Bailout set standing upright in uneven boots

- The rubber boots of each cylinder were uneven, which would likely have led to stress being placed on one side when moved around;
- The securing strap holding the bottles together was found to be loose;
- The design of *this particular* bailout manifold was less robust than other systems used elsewhere by the company.

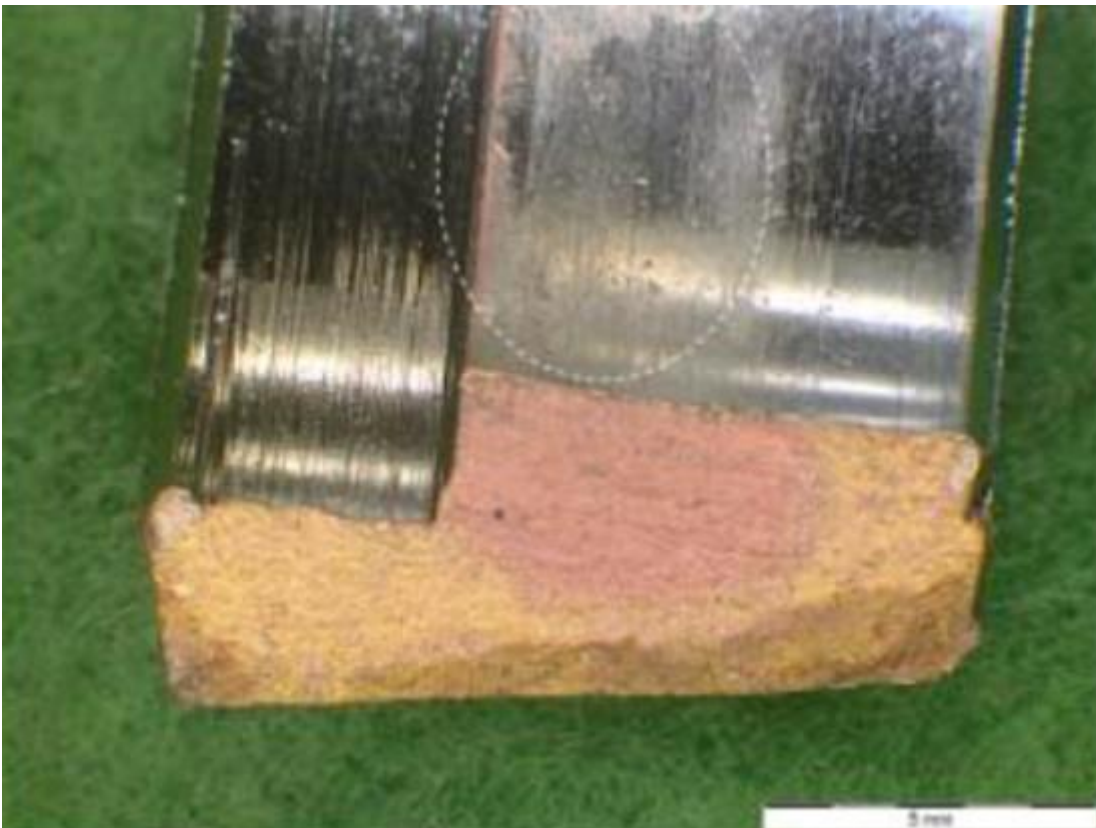
Failed nut showing some signs of coating removal and corrosion at point of a stress fracture (pink area)

Later forensic testing of the nuts from the manifold assembly supported the original root cause analysis which suggested that lateral force had likely been introduced due to inappropriate securing mechanisms. This led to stress corrosion cracking in the nut and allowed material ingress which caused internal corrosion over time.
