Near miss: divers umbilical drawn beneath a load

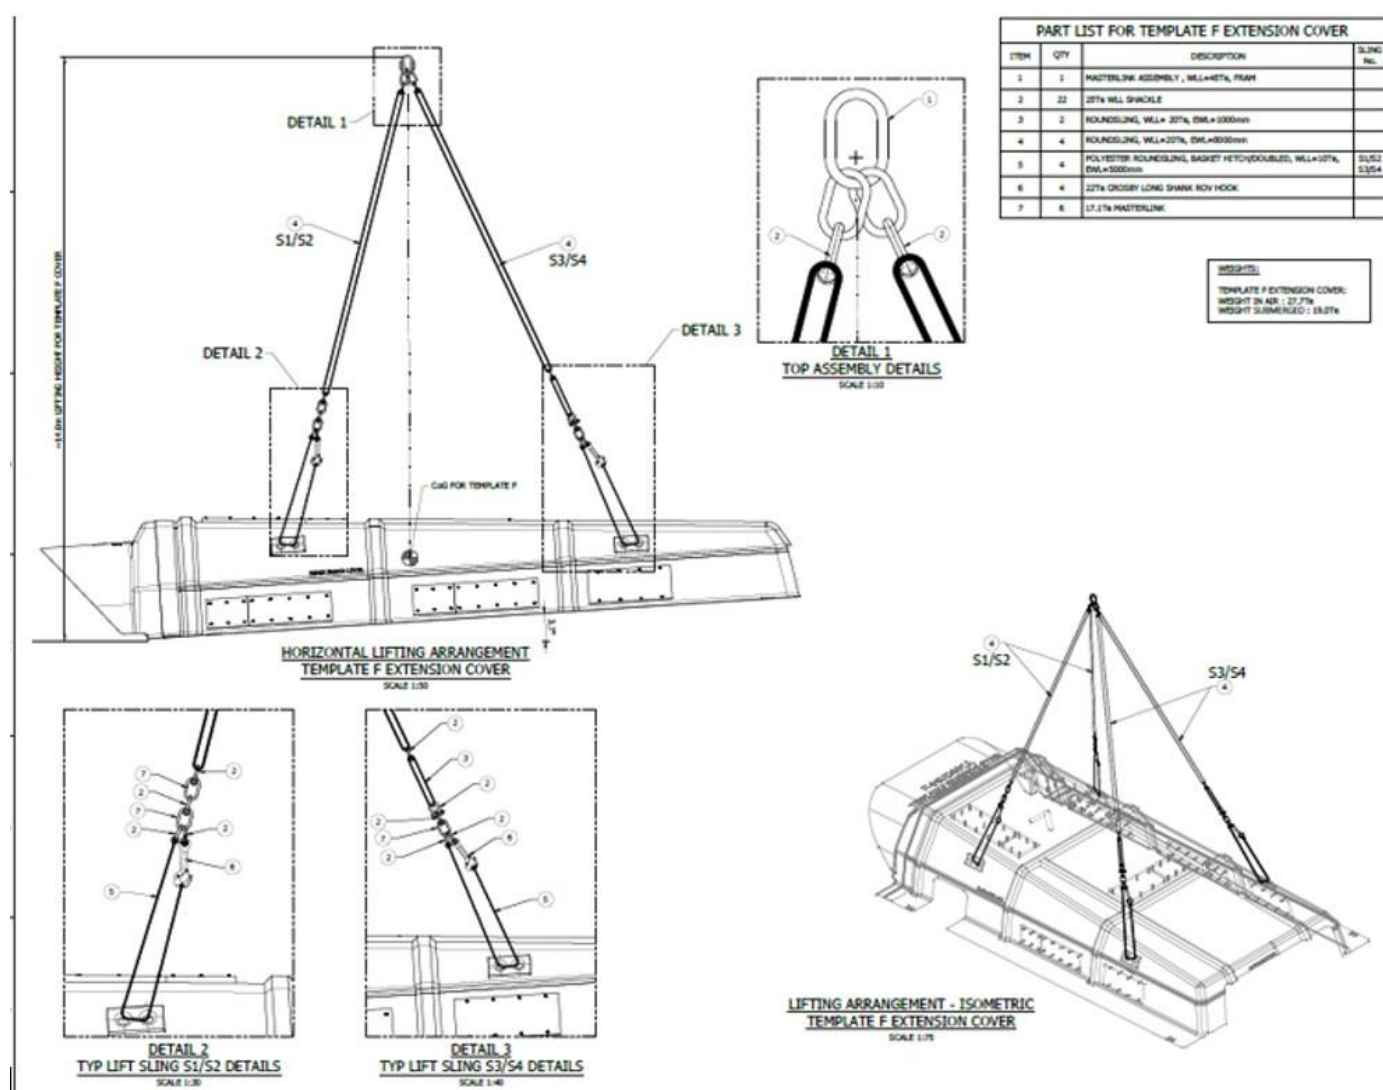
Suction from a large GRP (glass-reinforced plastic) cover during lifting resulted in a diver's umbilical being drawn beneath the load. The incident occurred during hook-up of the GRP lift rigging, when unexpected movement of the cover led to suction which drew Diver 1's umbilical under the corner of the cover. The cover was lifted and the divers' umbilical was cleared. The soft nature of the seabed prevented damage to the umbilical. There was no interruption to any diver's services, and no injuries.

During hook up of the cover, using crane active heave compensation, the vessel experienced heave which resulted in the cover being lifted in an unexpected way. This occurred when standing up the rigging in active heave compensation (AHC) to ensure there were no twists prior to switching modes into auto tension (AT). At that moment the vessel took a disproportionally large heave and consequently partially lifted the GRP cover.

Our member notes that large GRP covers (this one weighed over 20 tons) are notorious for the suction forces they create when being lifted, yet the diver needs to be close to enable the fine placement over assets.

Although the diver and dive supervisor were not expecting the GRP cover to lift, and good umbilical management had been identified as a requirement in the risk assessment, the potential for this movement of the umbilical to be sucked under the structure had not been identified and the appropriate umbilical management fully recognized.
