Information sourced from IMCA

Divers helmet struck and damaged subsea by crane hook

7/03/2025

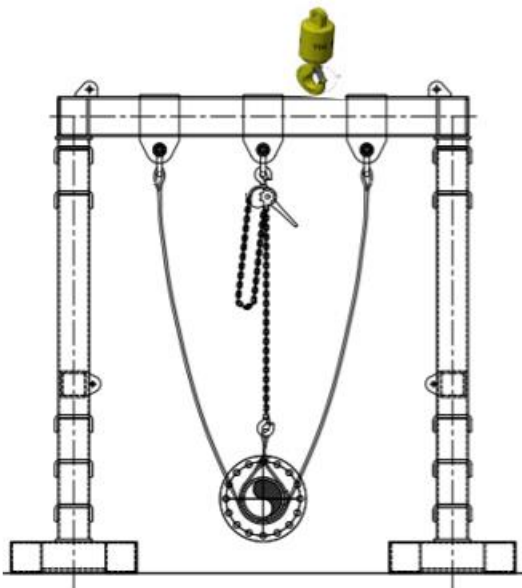
During subsea spool tie-in operations, a diver's helmet was struck and damaged by a crane hook due to misjudgement of its position in poor visibility. The crane operator reported 'no weight' on the wire, leading the Diving Supervisor to assume the hook had reached the seabed. As the diver moved to disconnect the rigging, the hook slipped off the pipe handling frame and struck the diver's helmet.

- Crane pennant/stinger was too short, bringing the hook too close to the diver.
- Poor visibility made it difficult to confirm equipment positions.

- Adjust crane pennant/stinger length to maintain safe distance from divers.
- Strengthen communication between Diving Supervisors and crane operators, especially in low visibility.
- Implement real-time tracking for improved equipment monitoring.
