*Information sourced from IMCA Safety Flash*

## LTI: person injured when hook parted during lifting operations

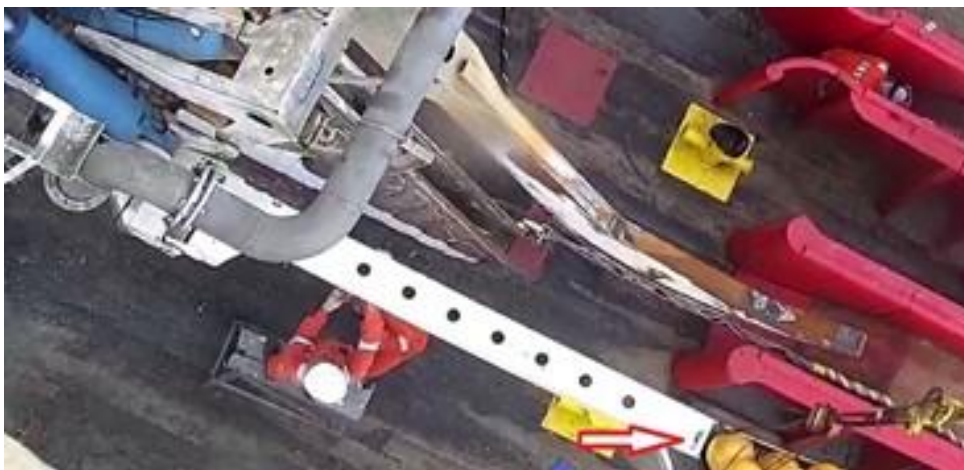
The plough depth skid, weighing around 320kg, was lifted at one end by the vessel crane; a fixed pad eye at the end of the skid was attached by a hook, sling and chain block. Suddenly the hook parted, and the depth skid fell down, knocking over both crewmen. Both landed badly; one of them sprained his leg; the other suffered a fractured wrist. Both were sent ashore by guard boat for medical treatment. Subsequent medical check showed that one of them suffered fractures of the left wrist and radial head (below the elbow).

Crew working under the depth skid which is lifted by crane. The red arrow shows the parted hook.

- It was shown afterwards that because the pad eye on the plough depth skid was too small for a standard hook, the crew used an entirely inappropriate spring snap hook to link the skid and the sling;
- The two crew were in the wrong place – under the load, in the line of fire.

- Further crew training on correct lifting loose gear application, emphasizing that unqualified loose gear should not be used for any lifting work;
- The pad eye was modified and tested so that a standard and properly qualified hook can be used;
- Hazard Identification and Risk Assessment form for plough operation was reviewed and revised:
  - To include safe positioning of crew and,
  - To enhance supervision by requiring the team leader to check safety positioning.

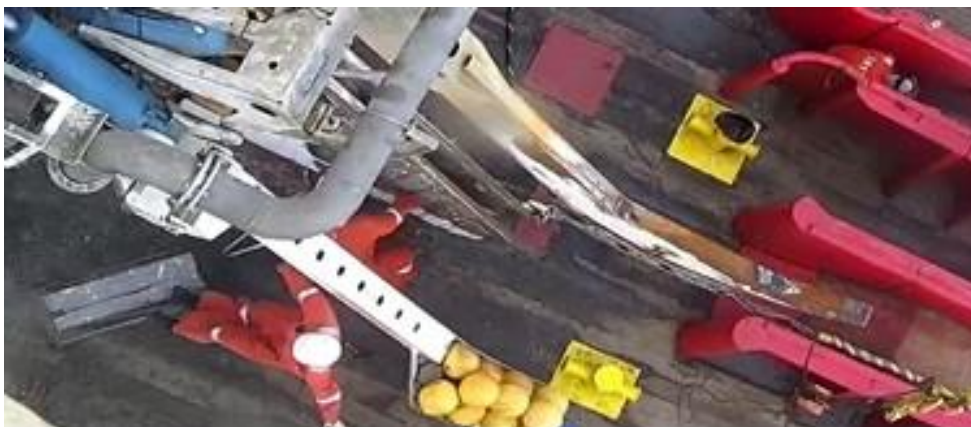
The skid in the fallen position
