Information sourced from IMCA Safety Flash

# Failure of 1 ton chain hoist

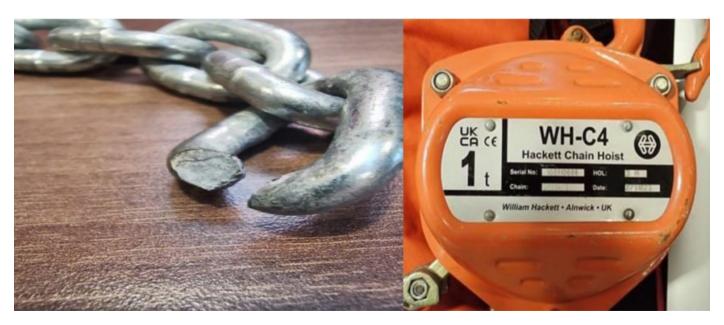
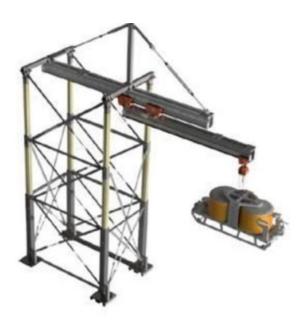
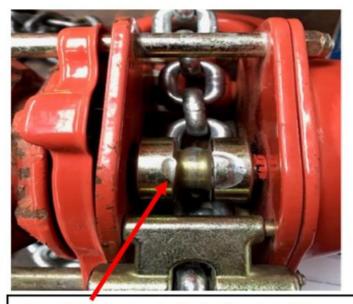
Findings indicated that at some point during the operation, the chain had entered the hoist in a twisted or knotted configuration and excessive force applied resulted in damage to the chain link which subsequently failed.

- Insufficient attention was given to ensuring that the chain between the block and the load was not twisted or in a knotted configuration;
- The headroom between the gantry beam and the tower floor was less than expected
  which resulted in the chain hook having to be pulled as tightly into the block as
  possible to keep the load clear of the floor. This put additional load into the chain and
  block and left nowhere for any residual twist in the chain to go, causing the damage to
  the chain and its subsequent failure.

Sign of compression, indicating the chain link was twisted side on and snapped due to the change in dynamic loading placed on the chain link.

When using a chain hoist, consider checking the chain for twists as it enters the block. Continually monitor the chain to ensure no twisting occurs. Avoid pulling the hook into the body of the hoist.
