BSEE: Nitrogen Cylinder Rupture Causing Worker Injuries and Equipment Damage

The United States Bureau of Safety and Environmental Enforcement (BSEE) has published [Safety Alert 494](#) relating to a Nitrogen Cylinder rupture which caused injuries and equipment damage.

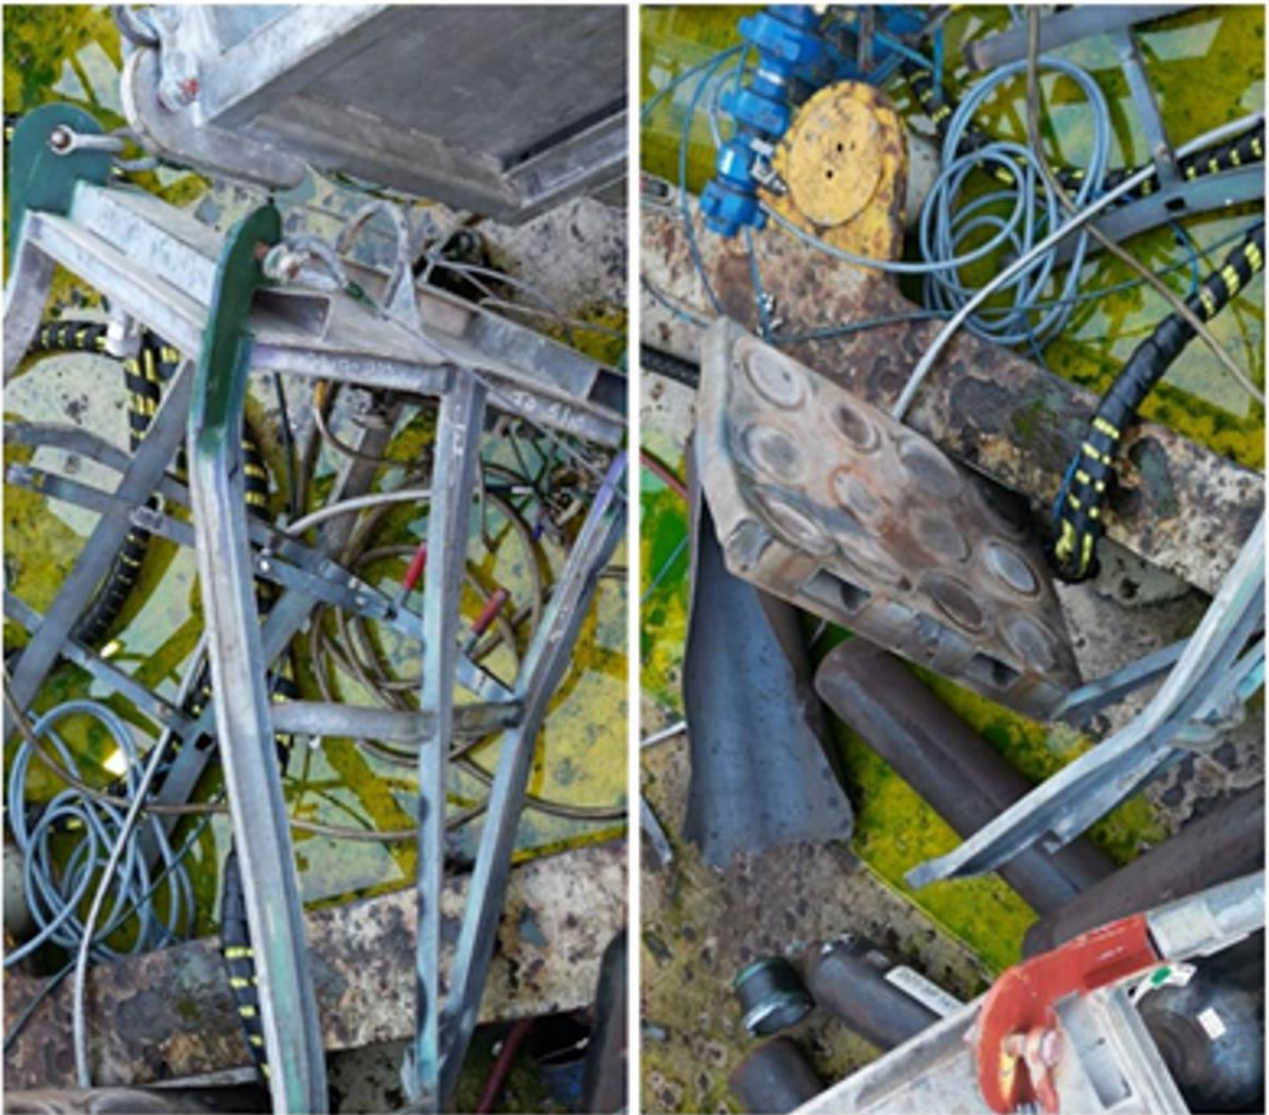
At the time of the incident, rig personnel had positioned a rack with 12 nitrogen cylinders to begin pre-charging the accumulator system cylinders with nitrogen. One of the nitrogen cylinders within the rack subsequently ruptured at its base, resulting in the dispersion of both the nitrogen cylinders and debris that was within the rack, as well as of the remaining cylinders situated in the immediate and port aft areas of the rig. Three rig personnel sustained minor injuries from shrapnel.

BSEE notes that “the failure of the nitrogen cylinder, which is attributed to corrosive wall loss exacerbated by environmental factors and structural conditions, highlights critical vulnerabilities in the storage and maintenance of nitrogen cylinders, particularly in marine environments. The presence of crevices at the base of the cylinders, combined with moisture accumulation, significantly accelerated the corrosion process, leading to the hazardous failure. Heavy deterioration of the galvanic coating on the storage rack further compounded the failure, indicating systemic neglect of maintenance protocols that could prevent such incidents.”

Post-Incident Images of Nitrogen Cylinder Rack and Debris.

- Ensure that all cylinders are properly labelled and marked with the appropriate markings required by local and international regulatory requirement;
- Verify that all cylinders are within their recertification period and have been properly recertified;
- Ensure that all cylinders are (only) filled to the appropriate pressure and the filling process is properly documented;
- Train all personnel handling and transporting high-pressure cylinders on the proper procedures and safety precautions;
- Train all personnel on the importance of monitoring environmental conditions and identifying the early signs of corrosion;
- Foster a culture of safety and diligence regarding the handling and maintenance of gas cylinders;

- Regularly review and update high-pressure cylinder safety procedures to ensure compliance with current regulatory requirements;
- Implement a robust inspection program and monitoring system to track the condition of high-pressure cylinders and storage racks regularly. Establish a reporting mechanism for any observed deterioration or safety concerns;
- Establish a routine maintenance schedule that includes cleaning, inspection, and protective coating application to prevent corrosion. This should also involve checking for and addressing any crevices or pooling of water around the bases of the cylinders.
