Information sourced from IMCA Safety Flash

## Non-fatal man overboard incident

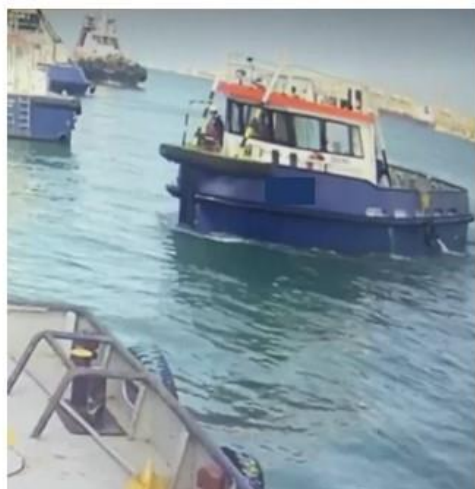
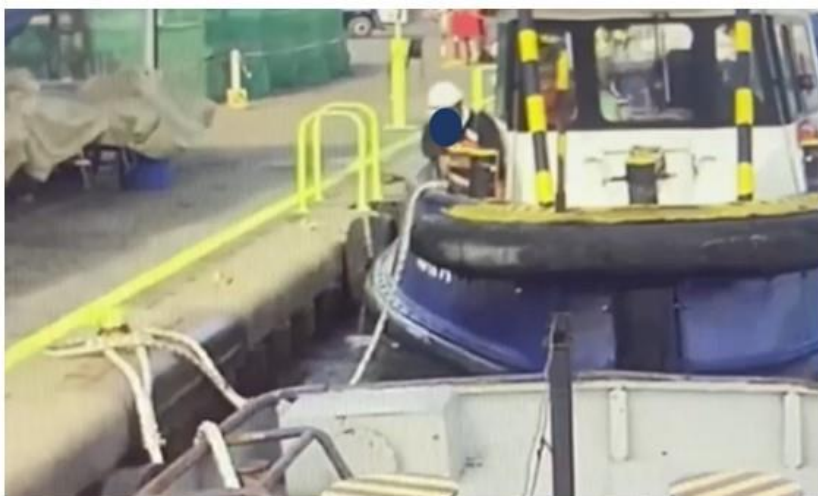
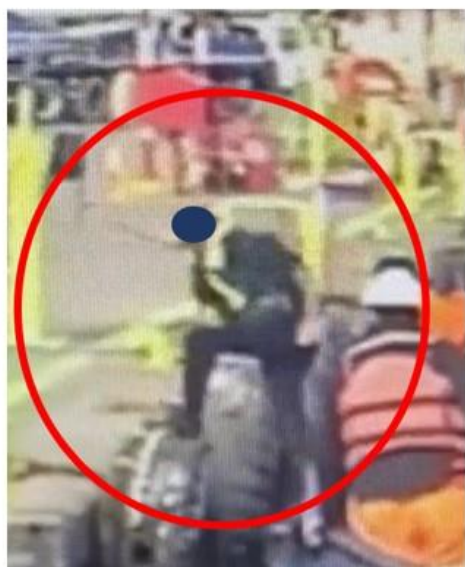
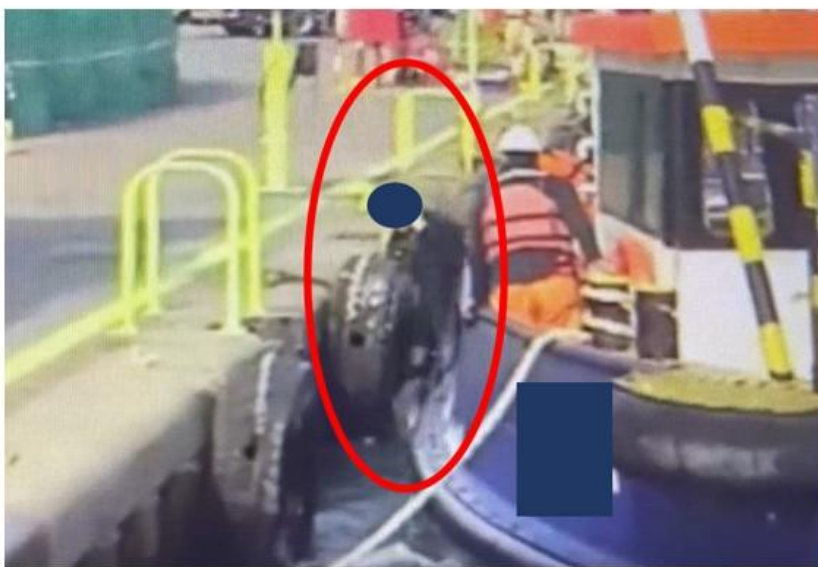
After completing work, a small mooring (pilot) boat returned to the jetty. The AB began to secure the forward spring line of the mooring boat. The pilot being transferred on the mooring boat attempted to disembark by jumping across the quayside fender before the vessel, missed the fender and fell into the water between the mooring boat and the jetty.

The pilot was uninjured in the fall; his life jacket inflated and he was able to swim to the jetty ladder and climb up to the quayside.

- The pilot attempted to disembark the vessel before the vessel was fully and securely moored;
- He was not wearing a helmet and very nearly hit his head on the jetty in the fall; had this occurred the incident may have resulted in a serious injury;
- Falling between the vessel and the quayside, he was fortunate not to be crushed;
- He was lucky: it was noted afterwards that his lifejacket had not been correctly secured; had it slipped off on impact with the water it would have failed to keep him above water.

- No one should disembark from any vessel until the vessel is completely alongside and securely moored;
- For vessels without gangways, a mandatory “buddy system” during personnel transfer was implemented, whereby another crew member on the shore side supports the crew member transferring from the vessel. Life jackets to be secured and correctly fastened before embarking/disembarking;
- For vessels with gangways, gangways should be securely fastened, and safety nets installed. After installation checks should be conducted to ensure it is secured safely, and the gangway controlled at all times.
